## MEMORANDUM

RE: CHEMICAL RECOVERY SYSTEMS SITE VISIT

DATE: 6/27/2012

**Chemical Recovery Systems Site Photographs, U.S. EPA Region 5**

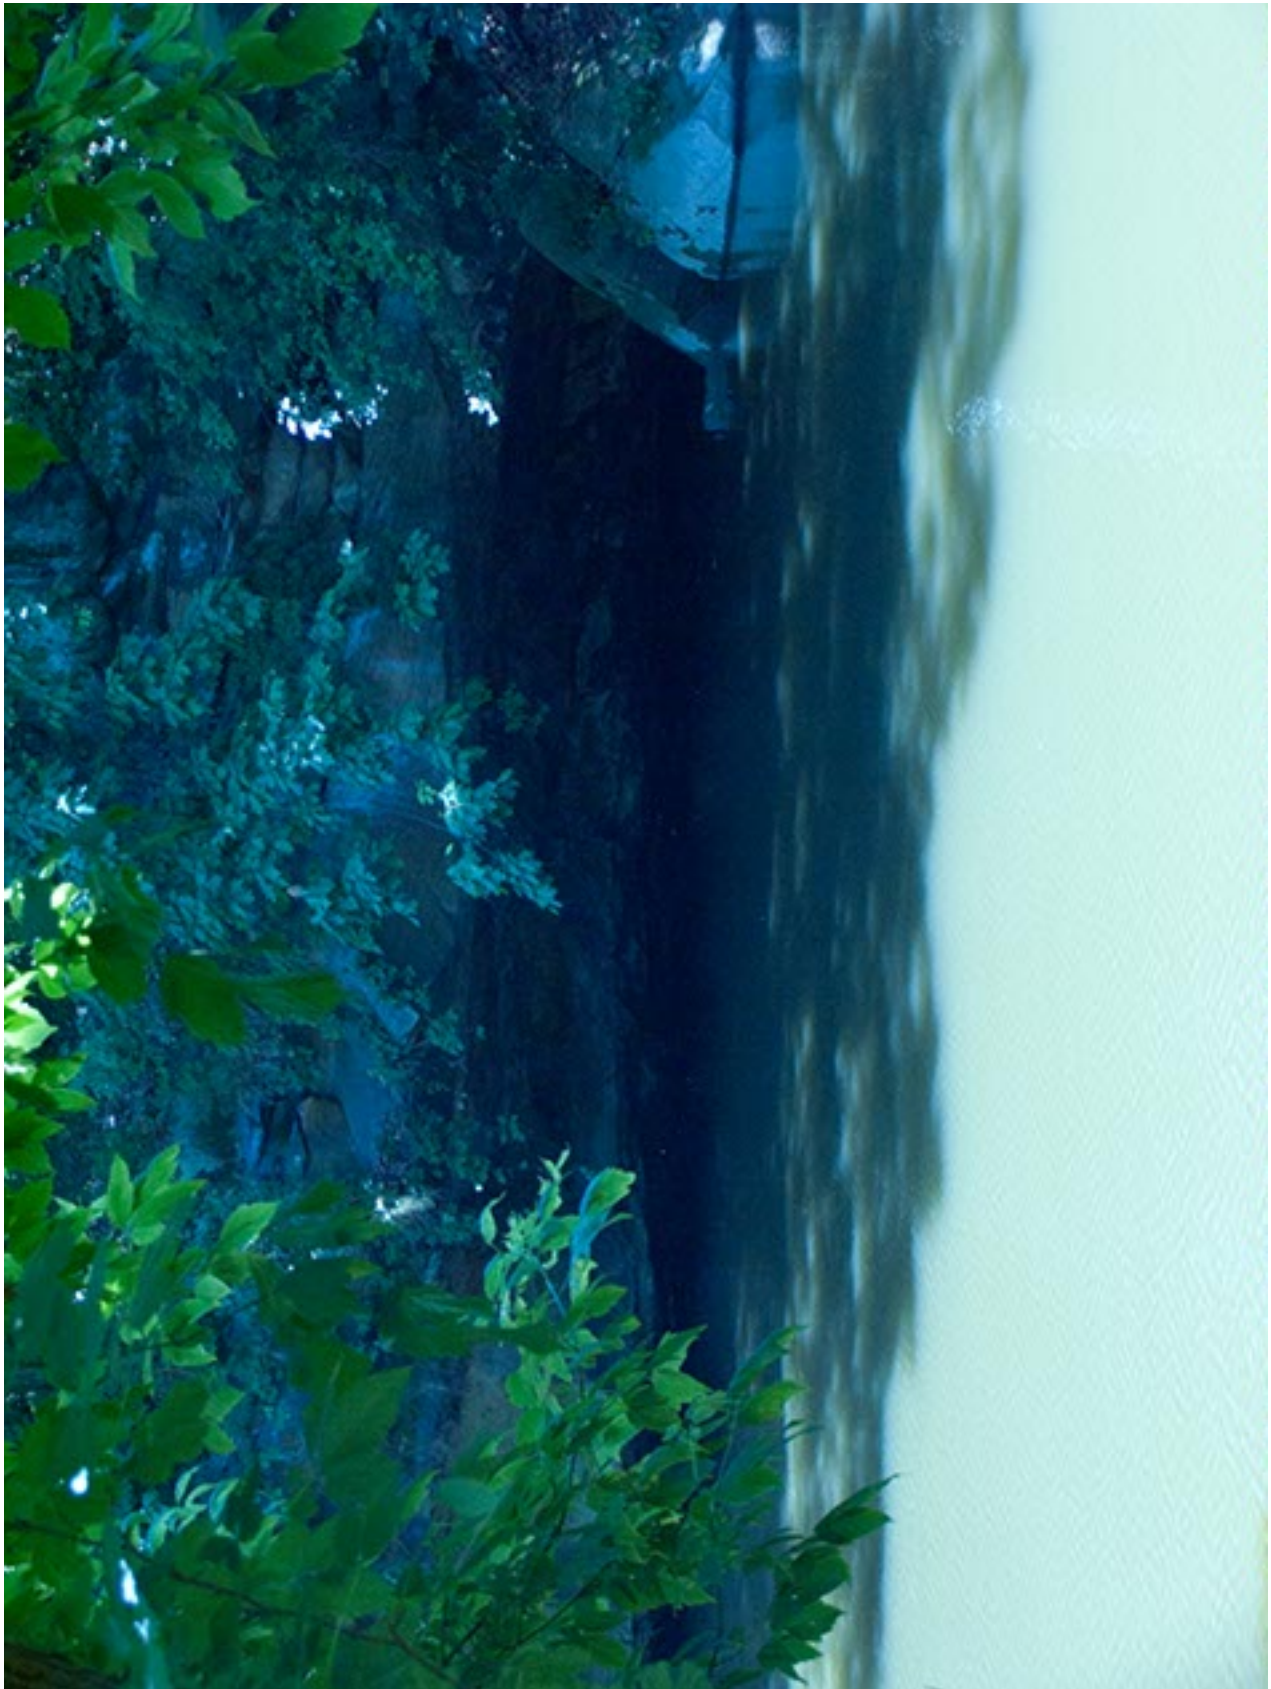
bedrock core11\_2012:6:14.JPG

Bedrock cores - J - extremely fractured, K also, compared to others. Cores I, J, K did not have complete sections of NAPL-impacted rock that were expected but still had acceptable sections for petrophysical analysis. Went 30 ft. down, & want to create core bit, & saw clean rock. Heavy NAPL impacts obsd. ~ 14-20 ft in bedrock. Fracture zones & continuous.

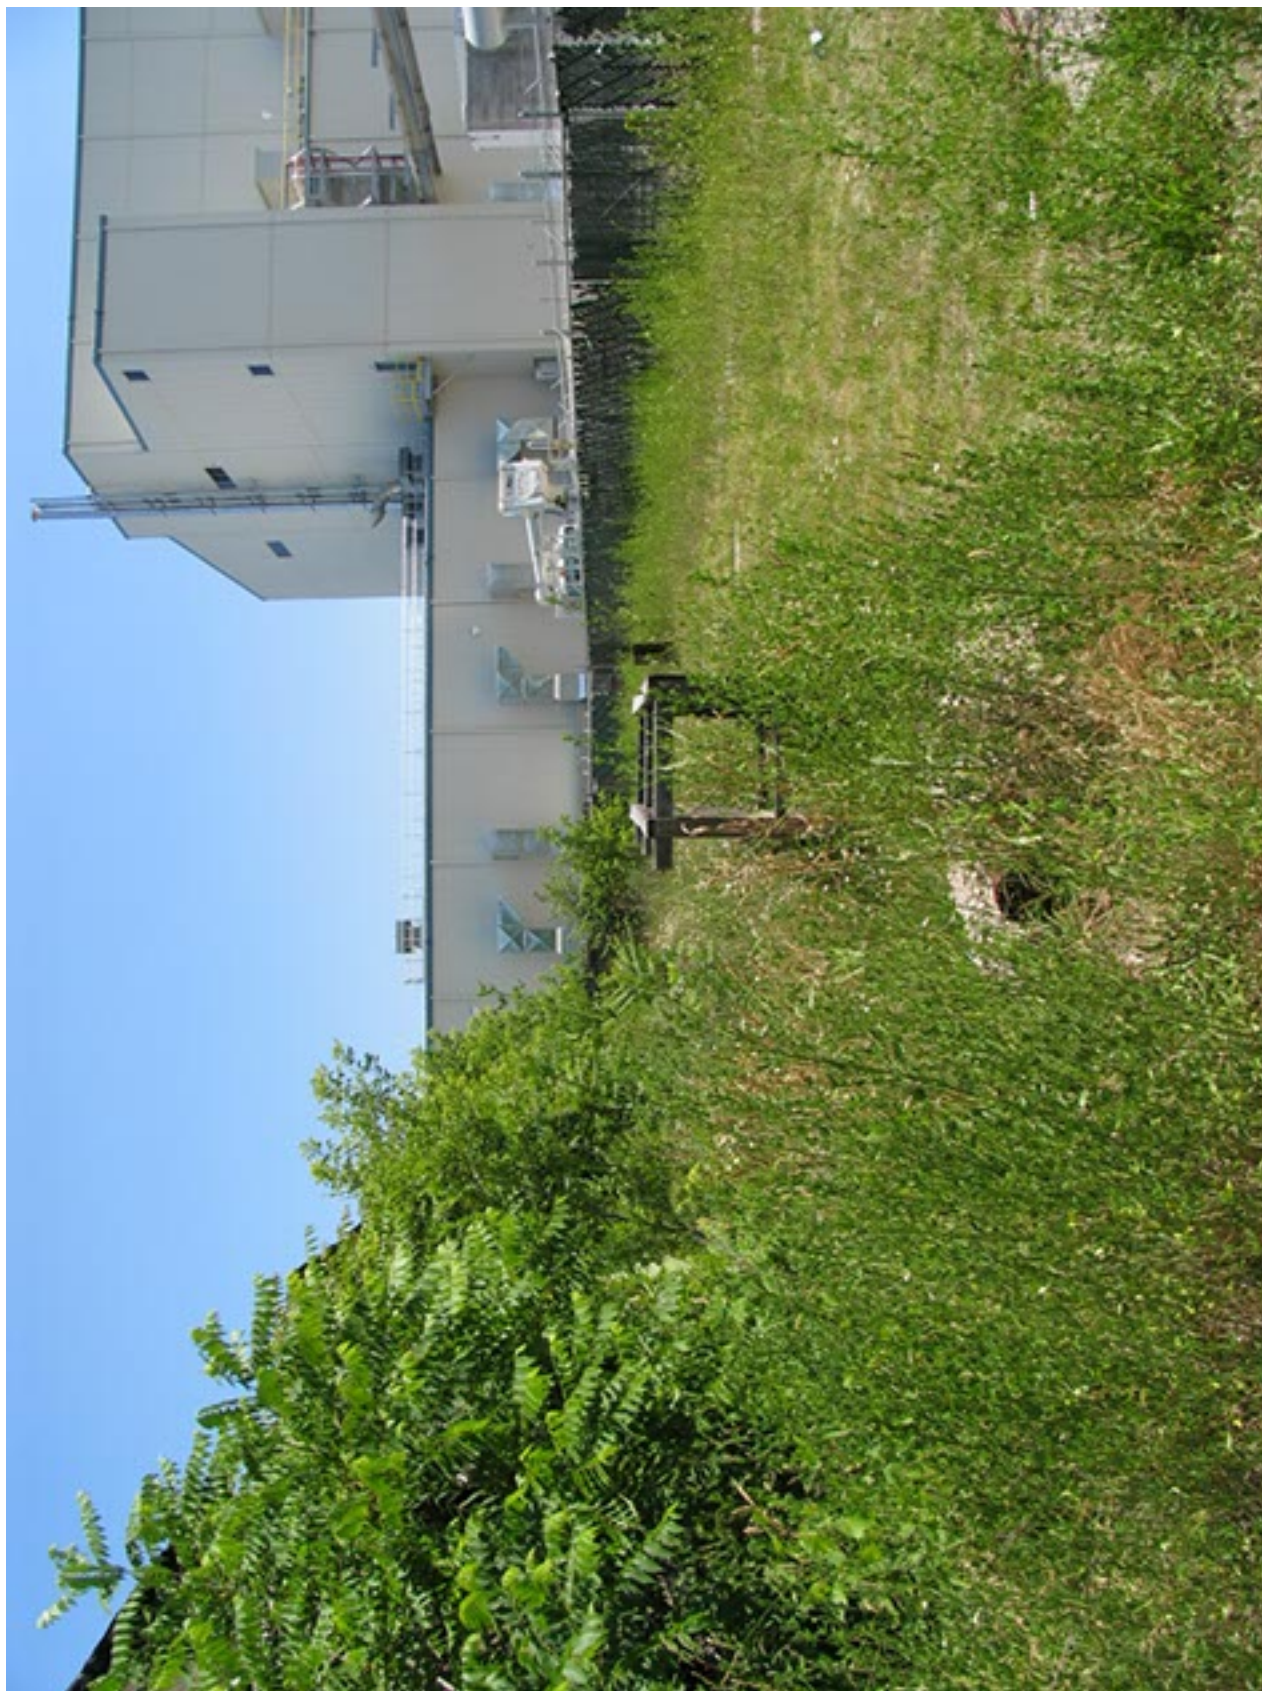
seep west bank Black River\_2012:6:14.CRW

Seep observations used for permeability measurements. Due to nature of seeps data will be mostly qualitative. E.g. long, slow zones on east bank south.
